6.12.5 The Four Cases

6.14.5 Structural Response of the WTC Towers to Fire without Impact or Thermal Insulation Damage

Aircraft Impact Damage

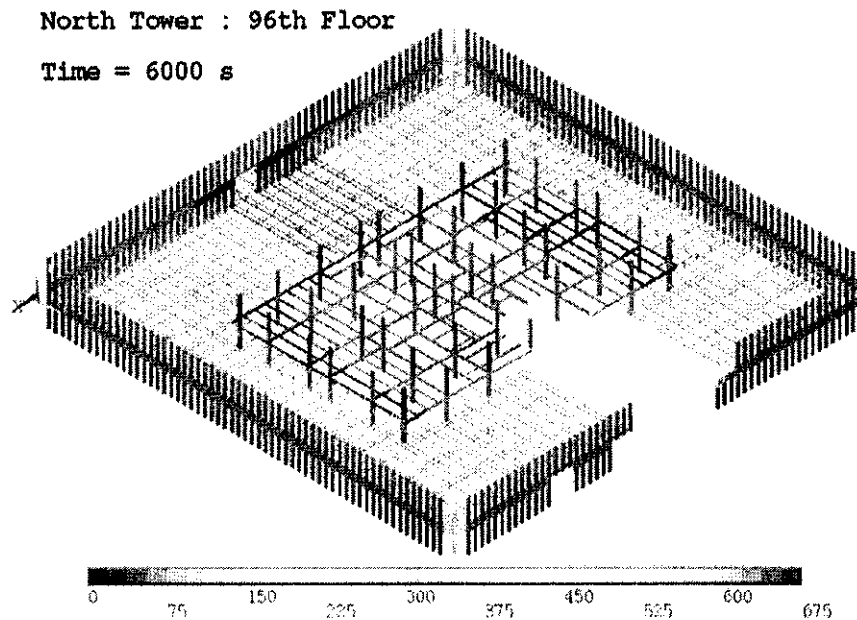
For ease of visualization, two graphic representations were developed. Figure 6–46 shows an example of the temperature map for the 96th floor of WTC 1. Severed columns and broken floor segments are not shown. Figure 6–47 shows a similar map for the 81st floor of WTC 2.

Figure 6–46. Temperatures (°C) on the columns and trusses of the 96th floor of WTC 1 at 6,000 s after aircraft impact, Case B.

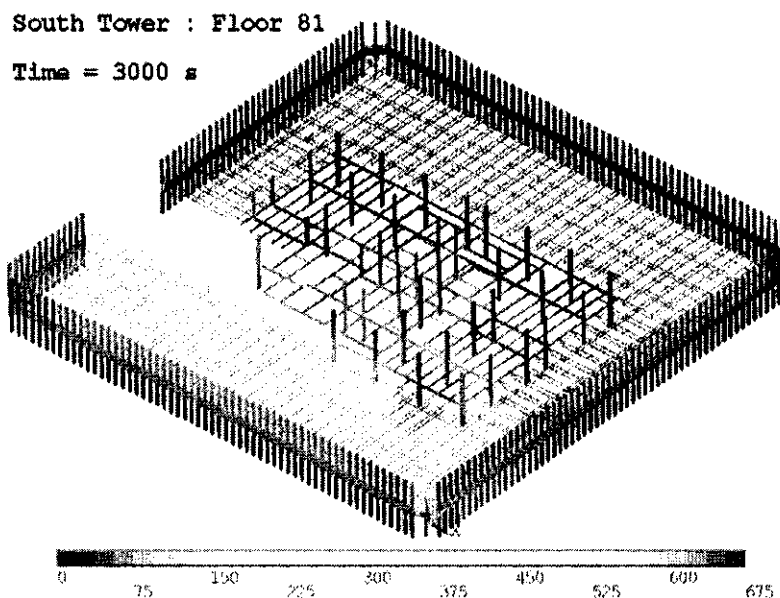
Figure 6–47. Temperatures (°C) on the columns and trusses of the 81st floor of WTC 2 at 3,000 s after aircraft impact, Case D.

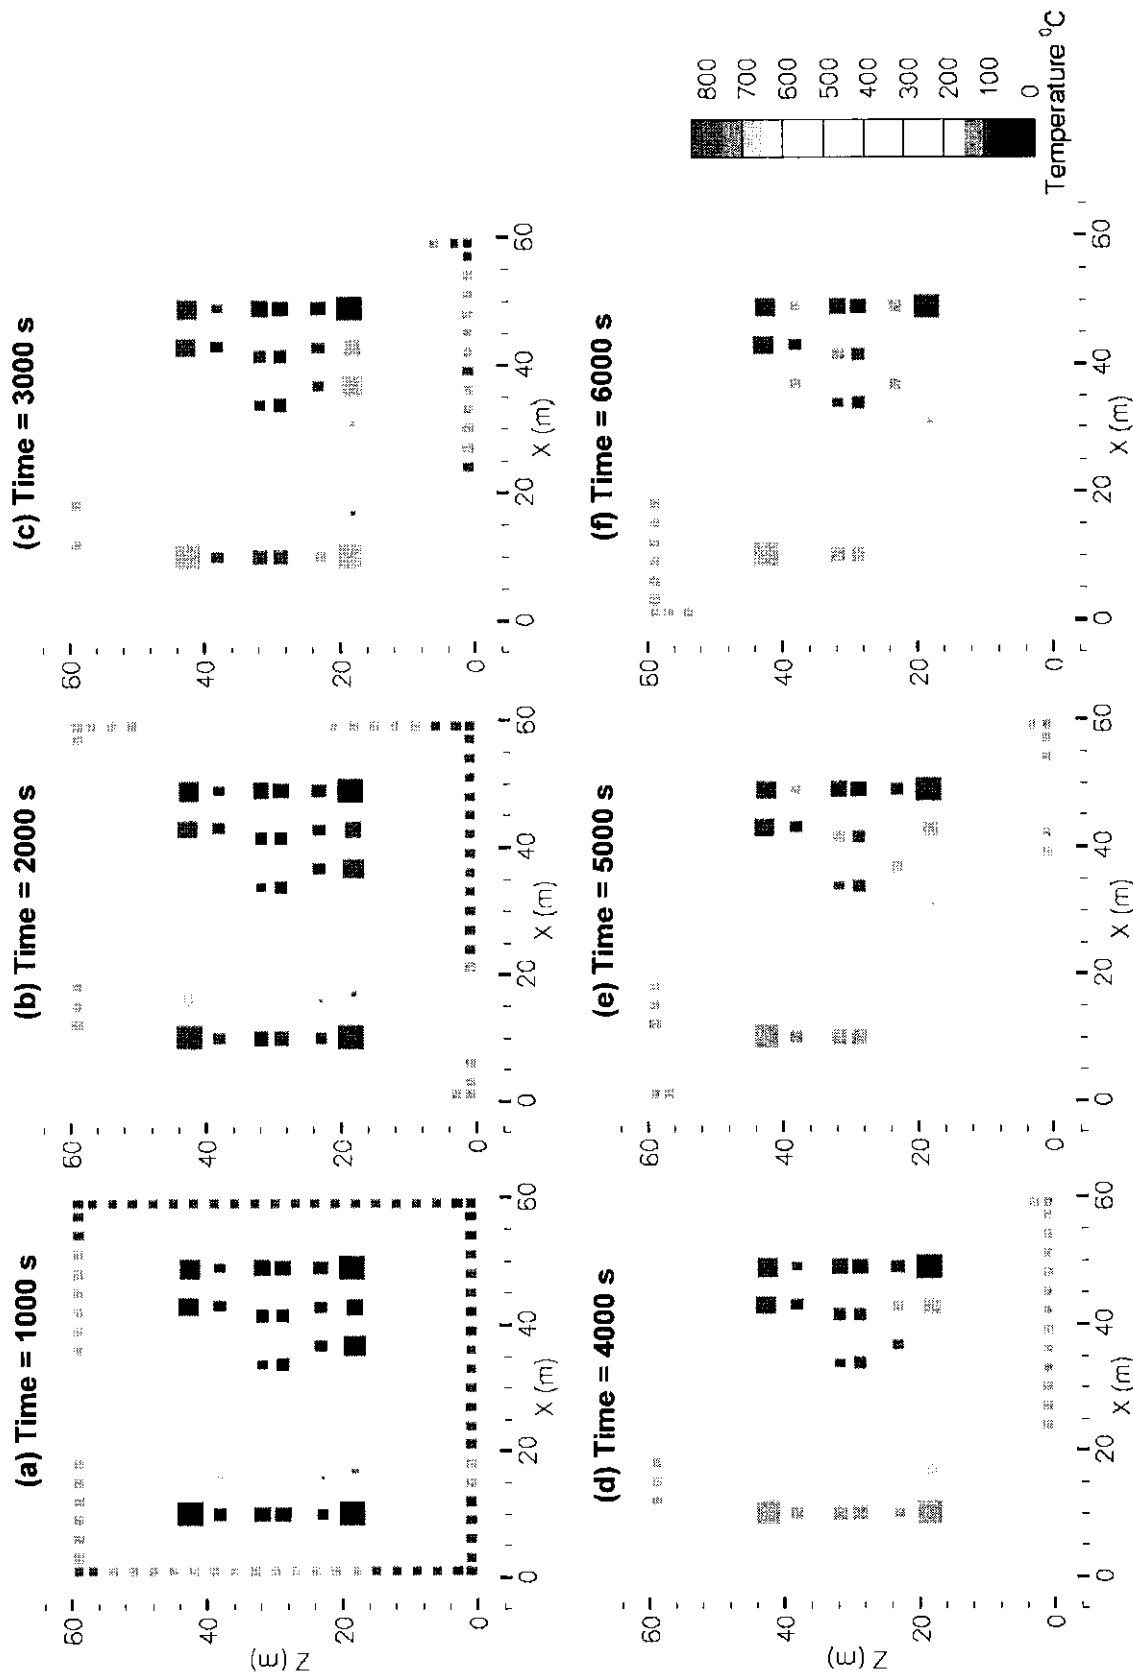
A third visualization tool was animation of the evolving temperatures of the columns. Frames from an example, again of the 96th floor of WTC 1, Case A, are shown in Figure 6–48. The size of the square representing a column represents its yield strength. Columns may have been heated when the fire was nearby and then cooled after the local combustibles were consumed.

Figure 6-48. Frames from animation of the thermal response of columns on the 96th floor of WTC 1, Case A.

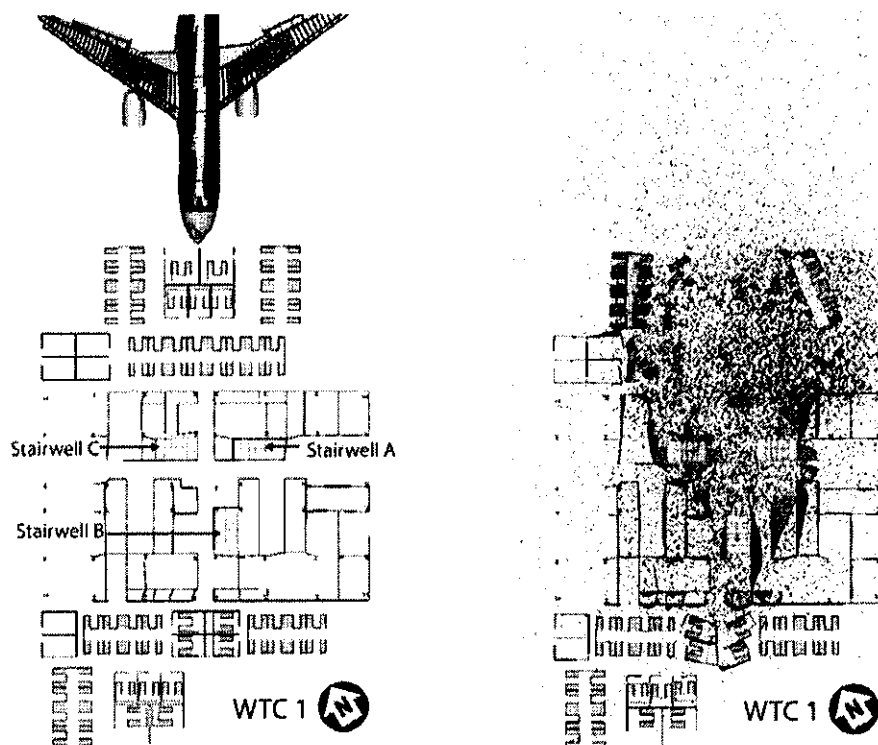
Figure 7-1. Simulated impact damage to 95th floor of WTC 1, including stairwells, 0.7 s after impact.

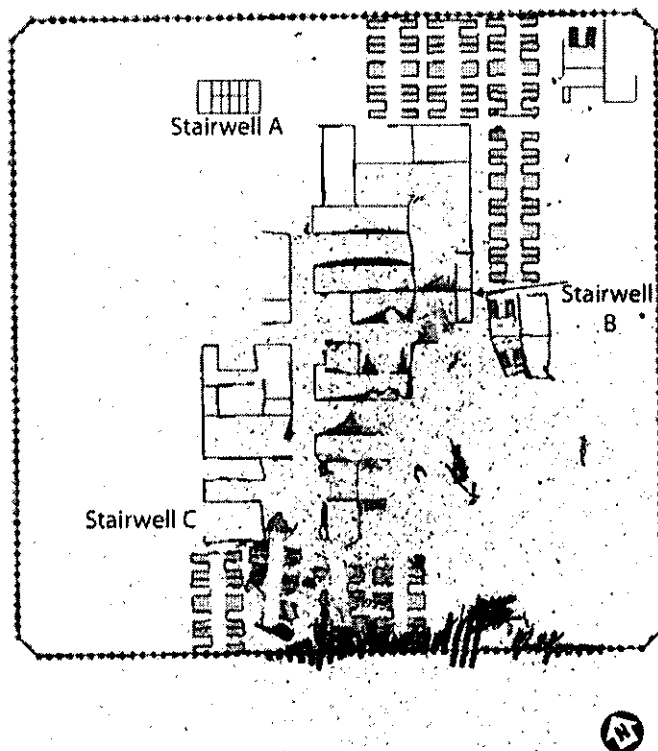
along different boundaries of the building core. United Airlines Flight 175 destroyed Stairwells B and C, but not Stairwell A (Figure 7-2).

Figure 7-2. Simulated impact damage to WTC 2 on floor 78, 0.62 s after impact.

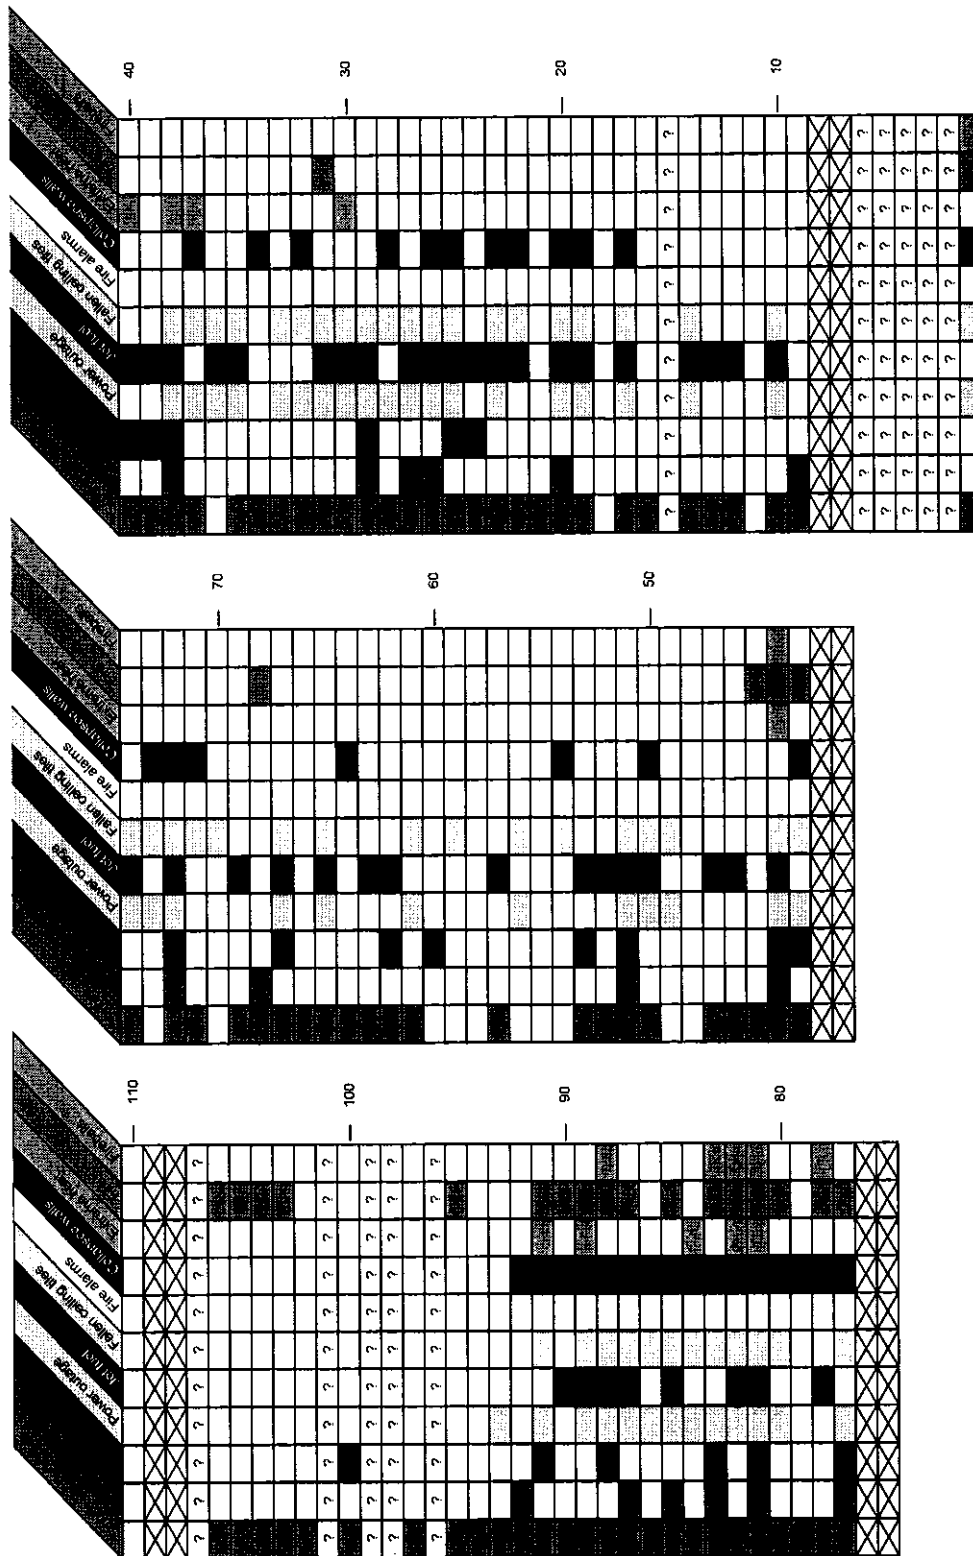
- Occupants throughout the building observed various types of impact indicators throughout the building, including wall, partition, and ceiling damage and fire and smoke conditions. The filled-in squares in Figure 7-3 indicate the floors on which the different observations were reported.

Figure 7–3. Observations of building damage after initial awareness but before beginning evacuation in WTC 1.

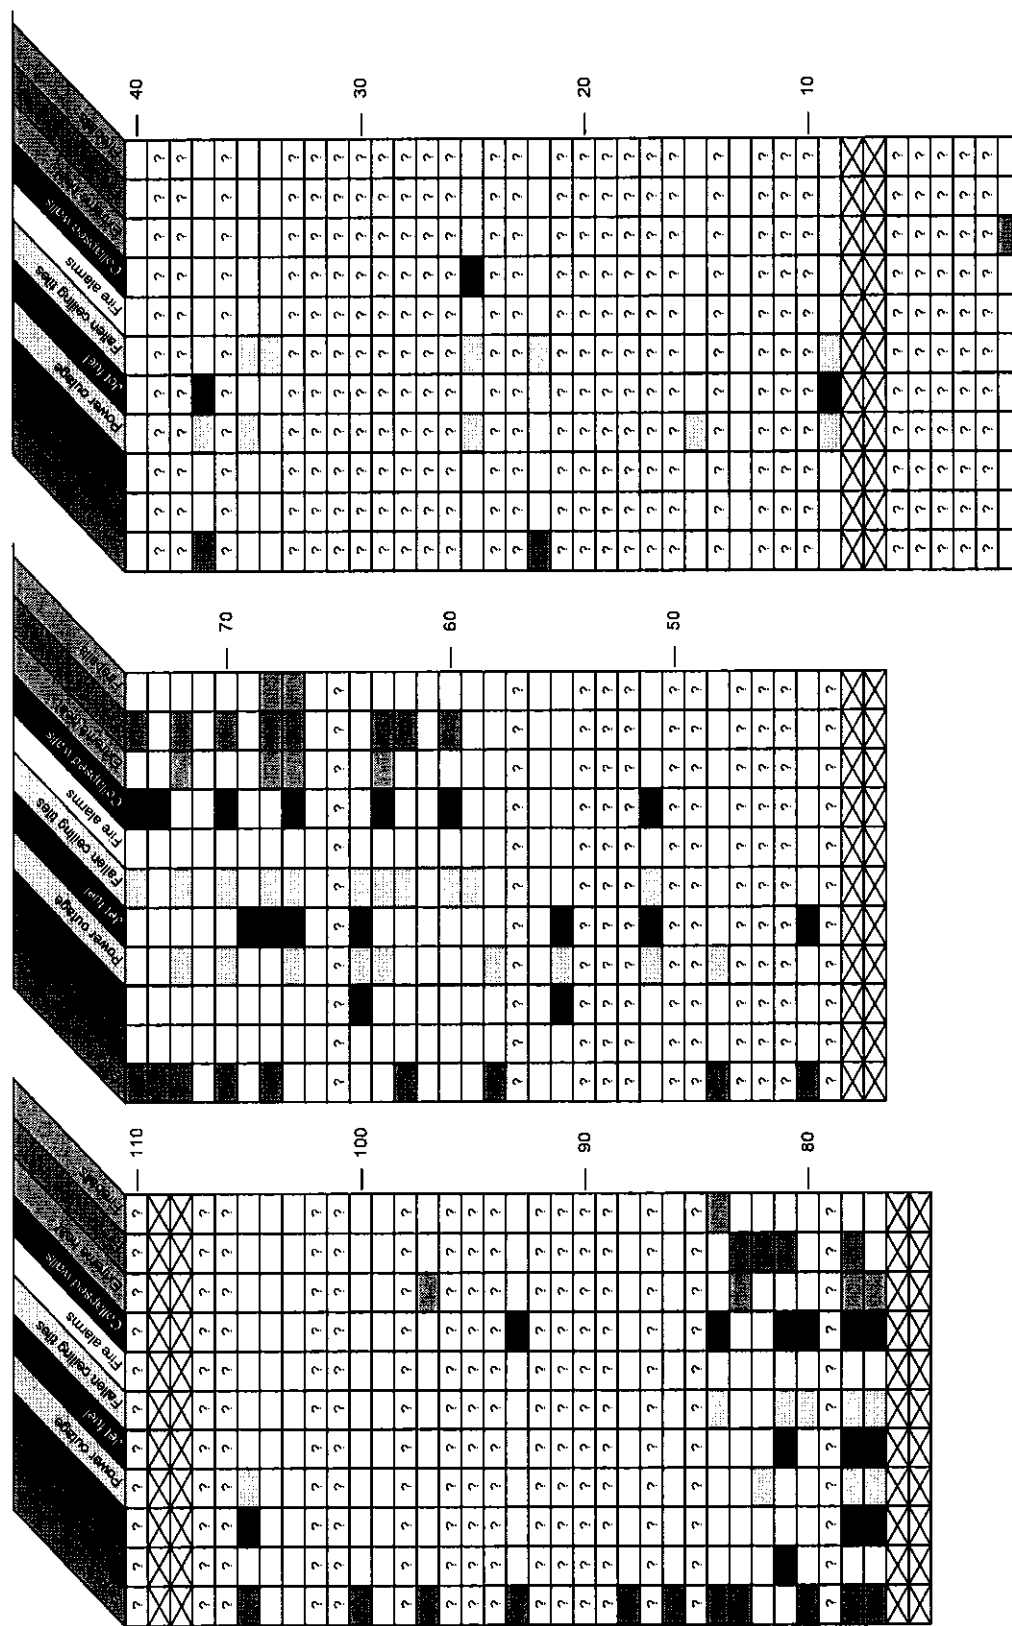
Figure 7-4. Observations of building damage from tenant spaces in WTC 2.
